## Is the Nemasket River Stressed Out?

Apponequet Regional High School, Lakeville, Massachusetts (2007). *Is the Nemasket River Stressed Out?*. In Watershed Access Lab Projects. Project 59.  
Available at: [http://vc.bridgew.edu/wal\\_projects/59](http://vc.bridgew.edu/wal_projects/59)

# Introduction to the Nemasket River

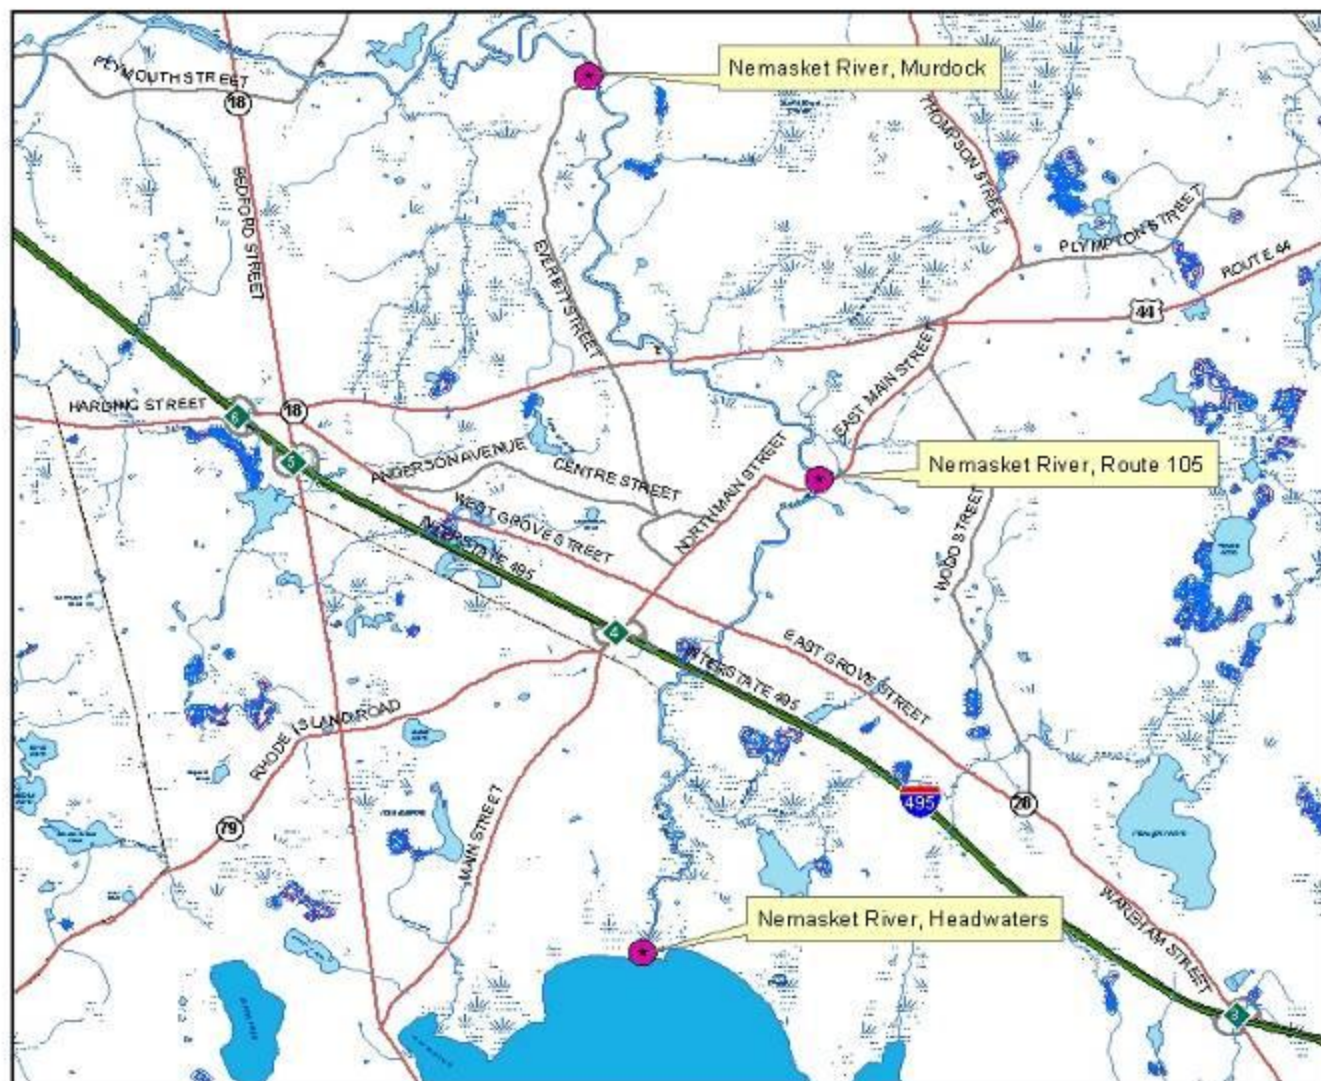
## Nemasket River Sites

- What is the effect of the Middleborough Waste Water Treatment Plant on the water quality of the Nemasket River?
- We used three sites: Headwaters, Route 105, and Murdock Street
- We also used water quality indicators such as nutrient load, dissolved oxygen, pH, and Family Biotic Index of macro invertebrates at Murdock Street and Route 105.

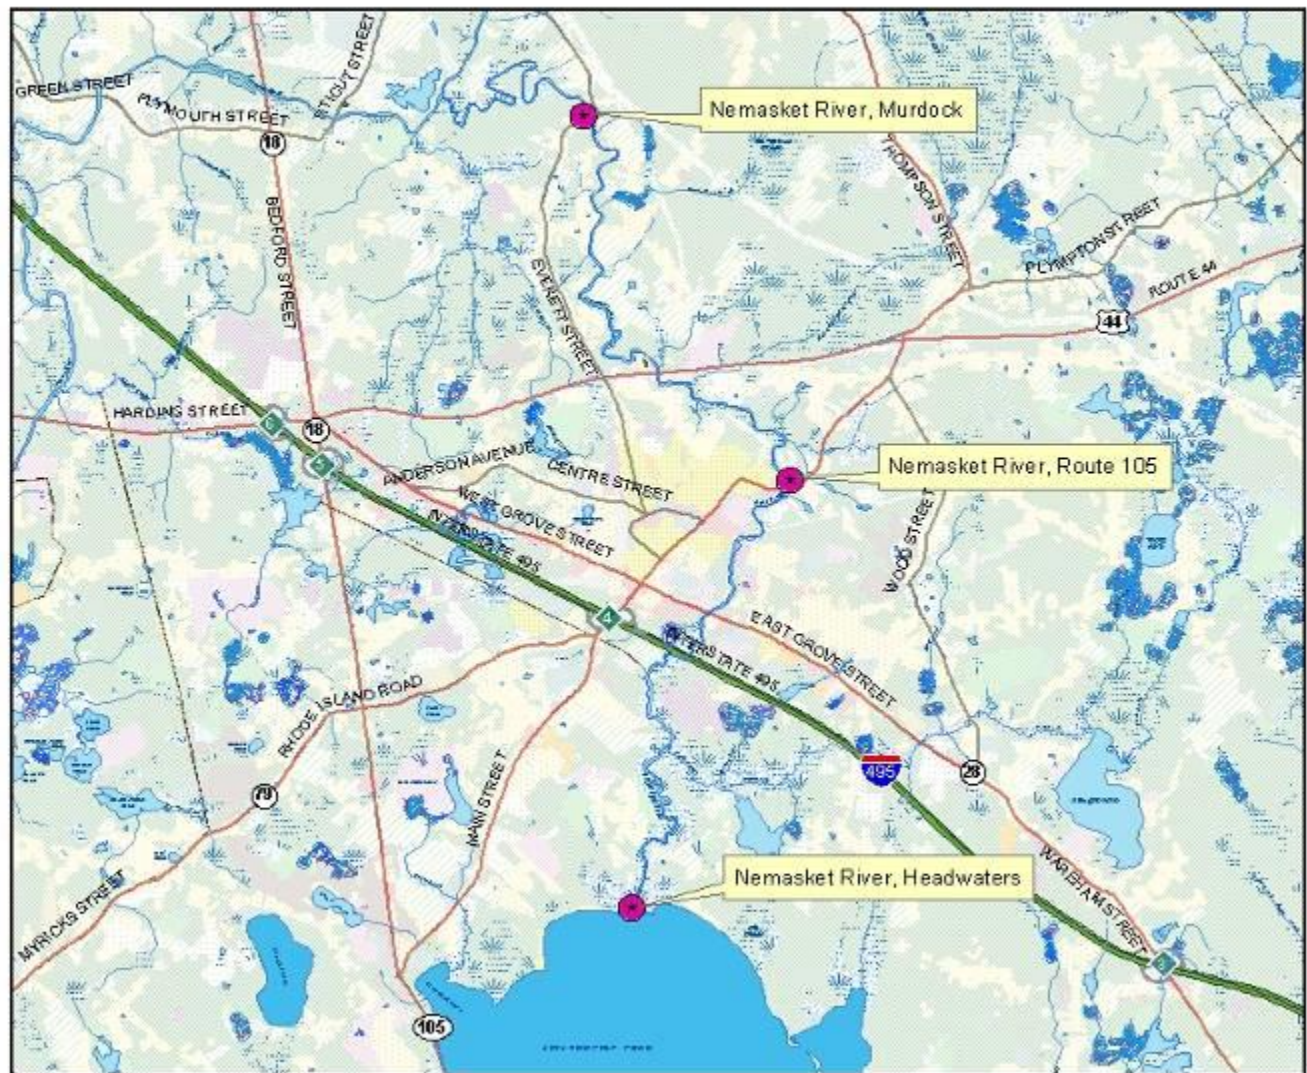
## Nemasket River Land Uses

- The Nemasket River flows from Assawompsett Pond.
- We calculated the sub-basin area
- Land uses around the Nemasket.

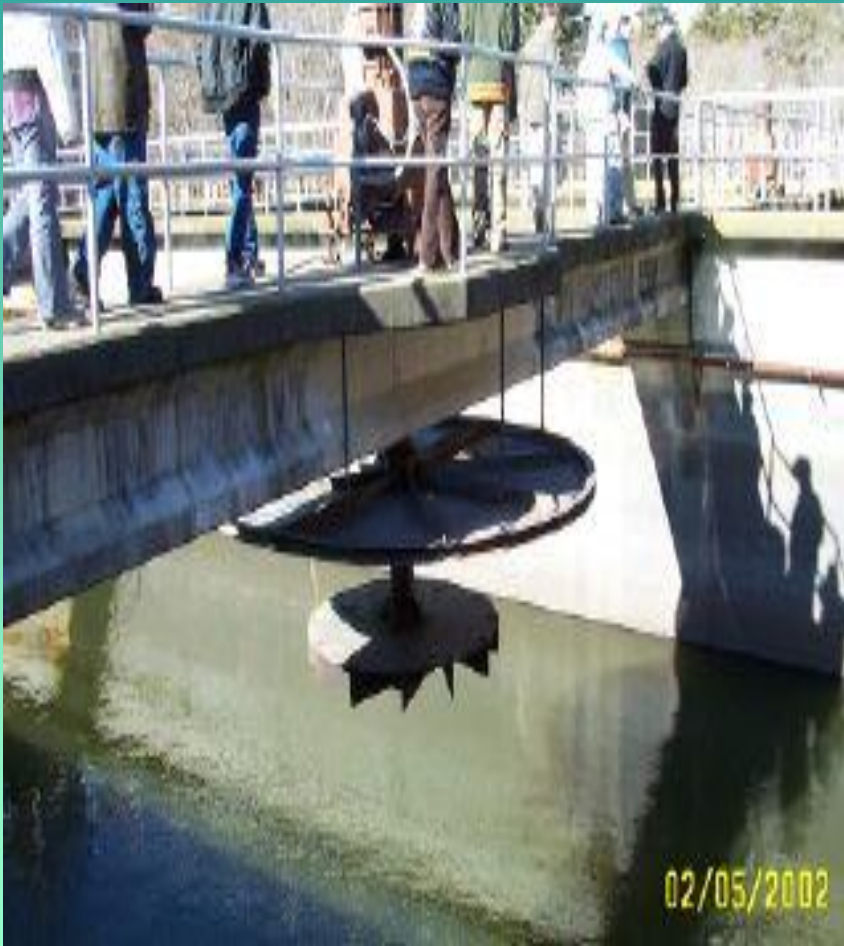
# Middleborough Waste Water Treatment Plant

- The Waste Water Treatment Plant is located between our Route 105 and Murdock Sites.
- The NPDES permit allows 2.6MGD to be dumped into the water.

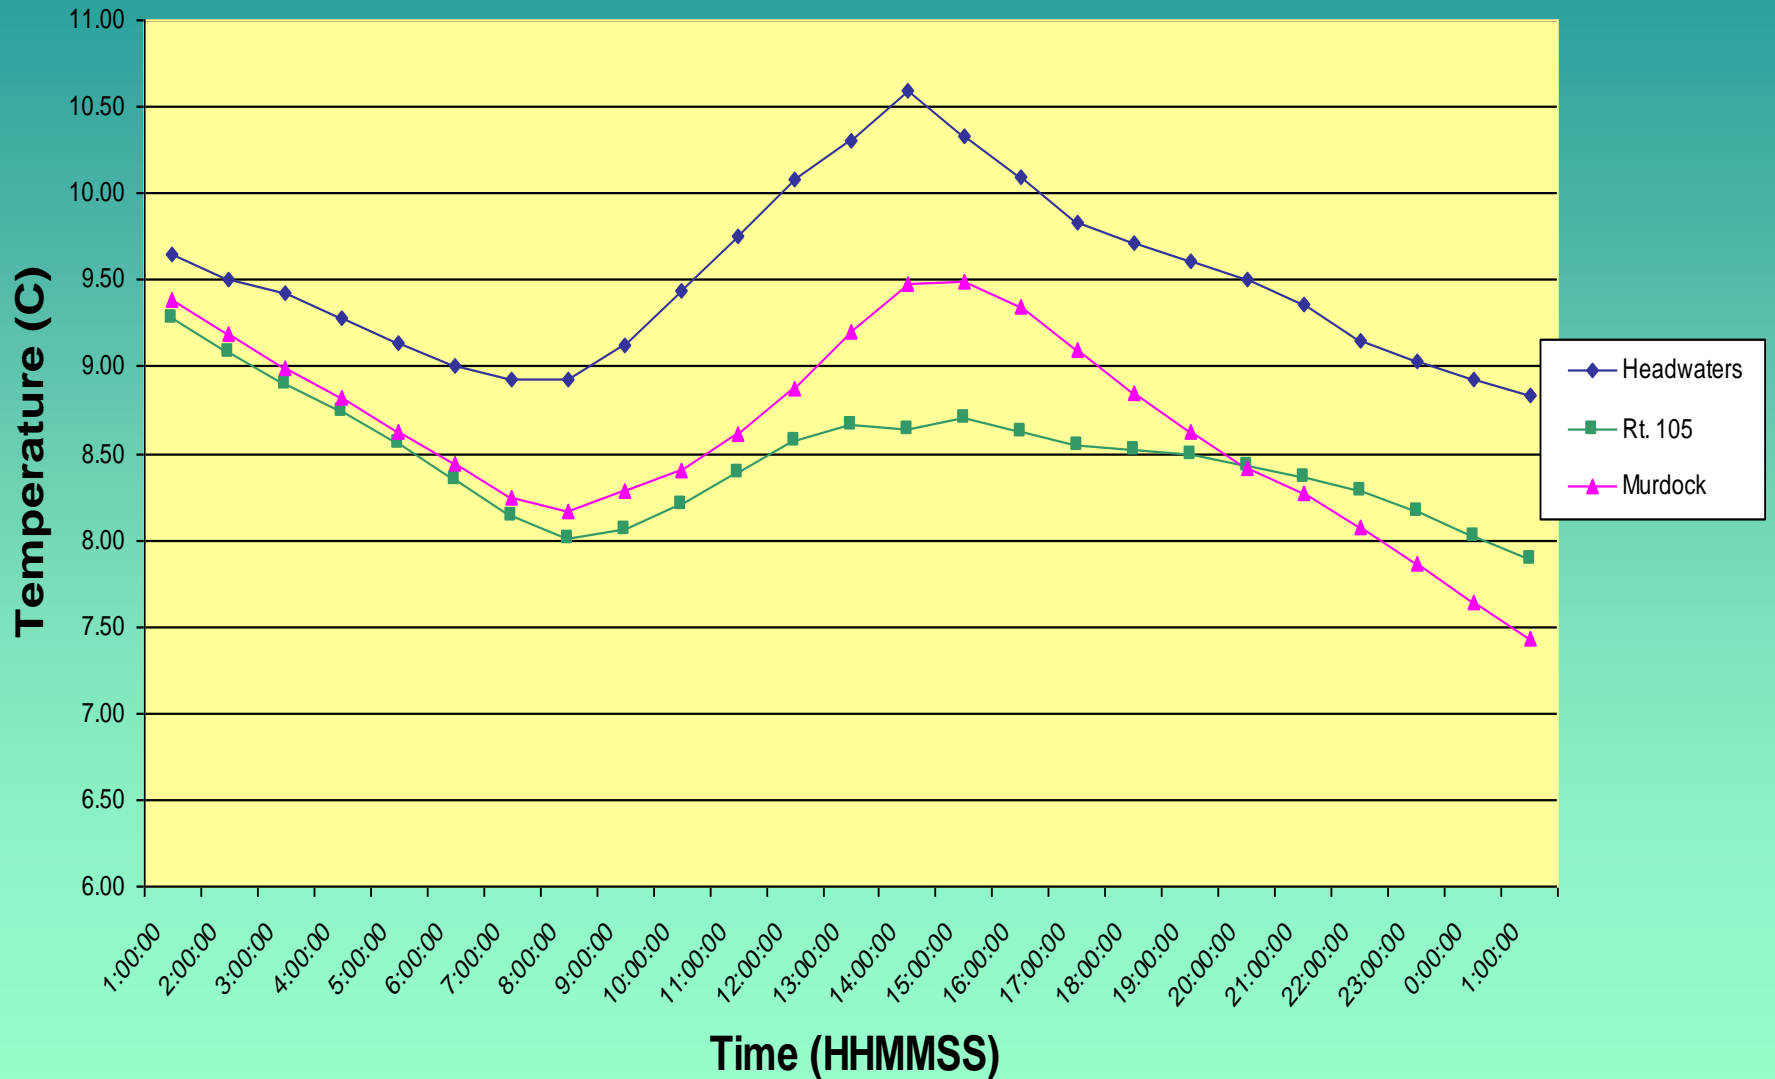
# Temperature vs. Time, Nemasket River, Nov.3-4, 2006

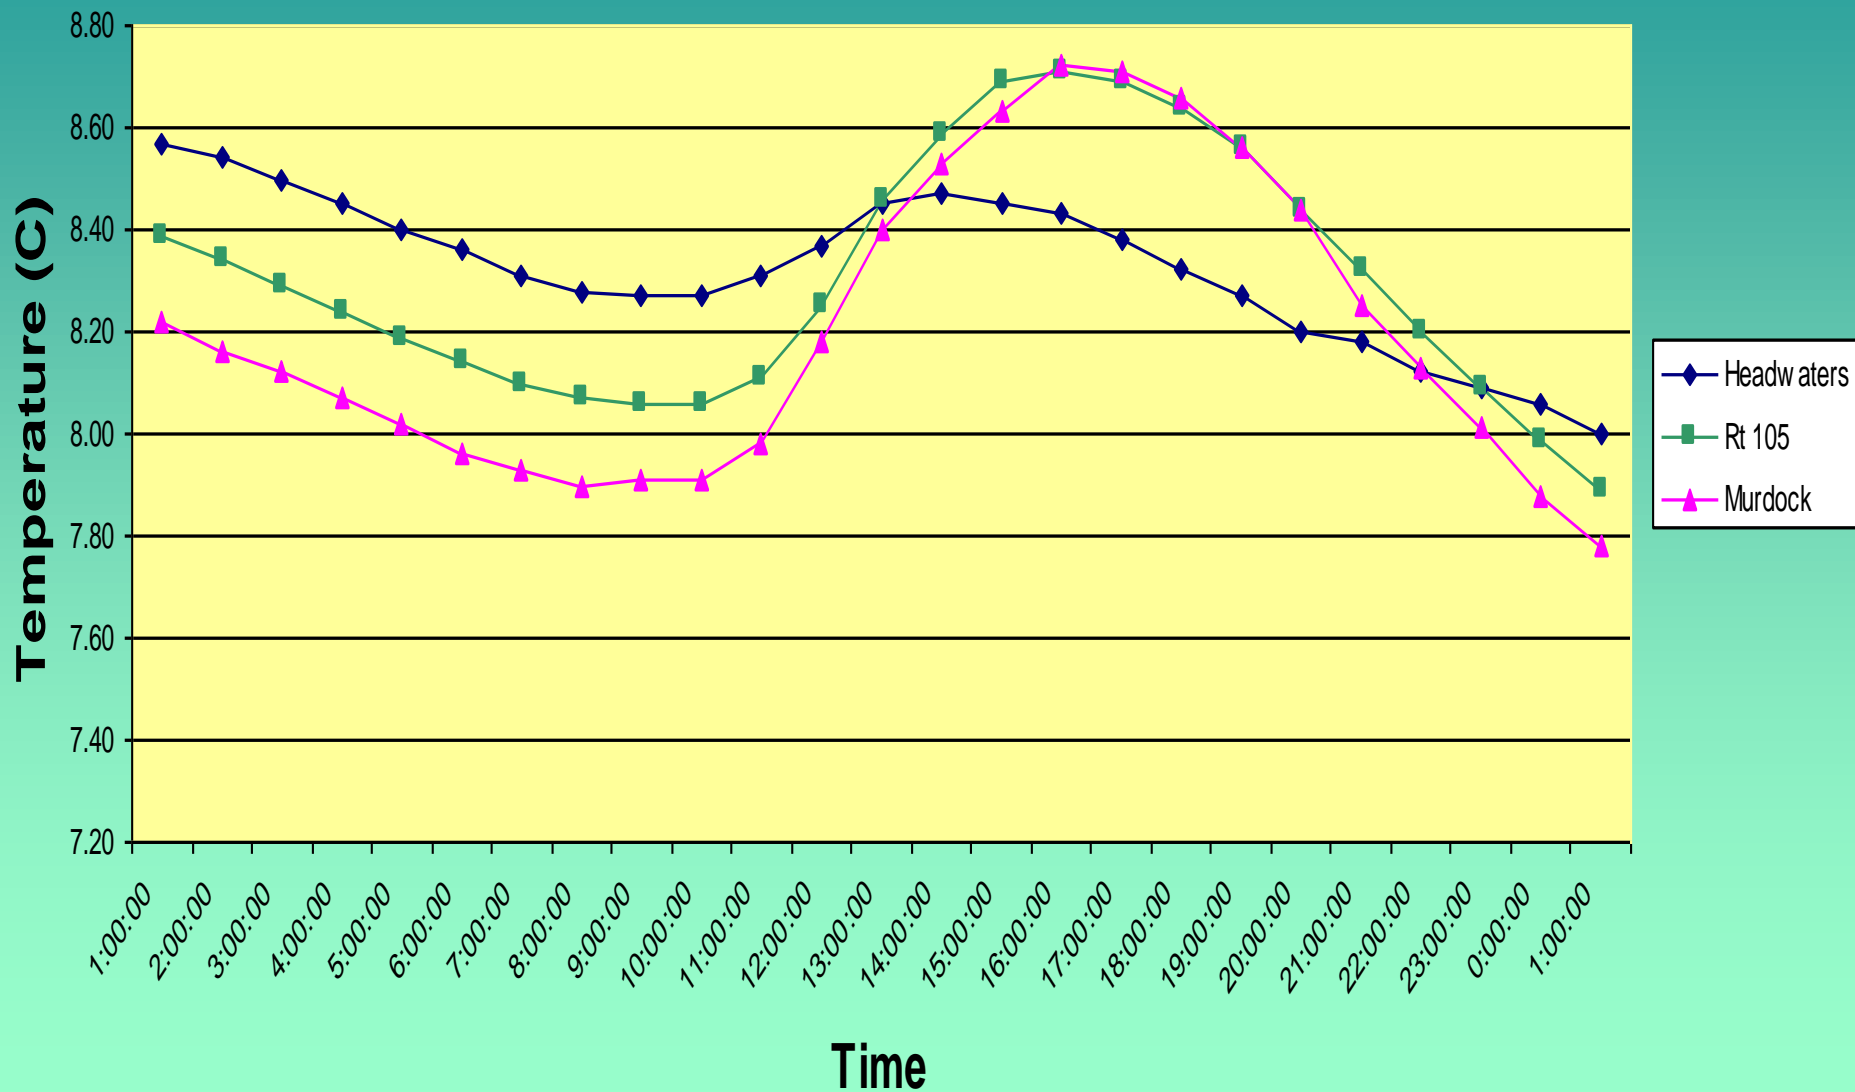
# Temp. vs. Time, Nemasket River, 04/03/07-04/04/07

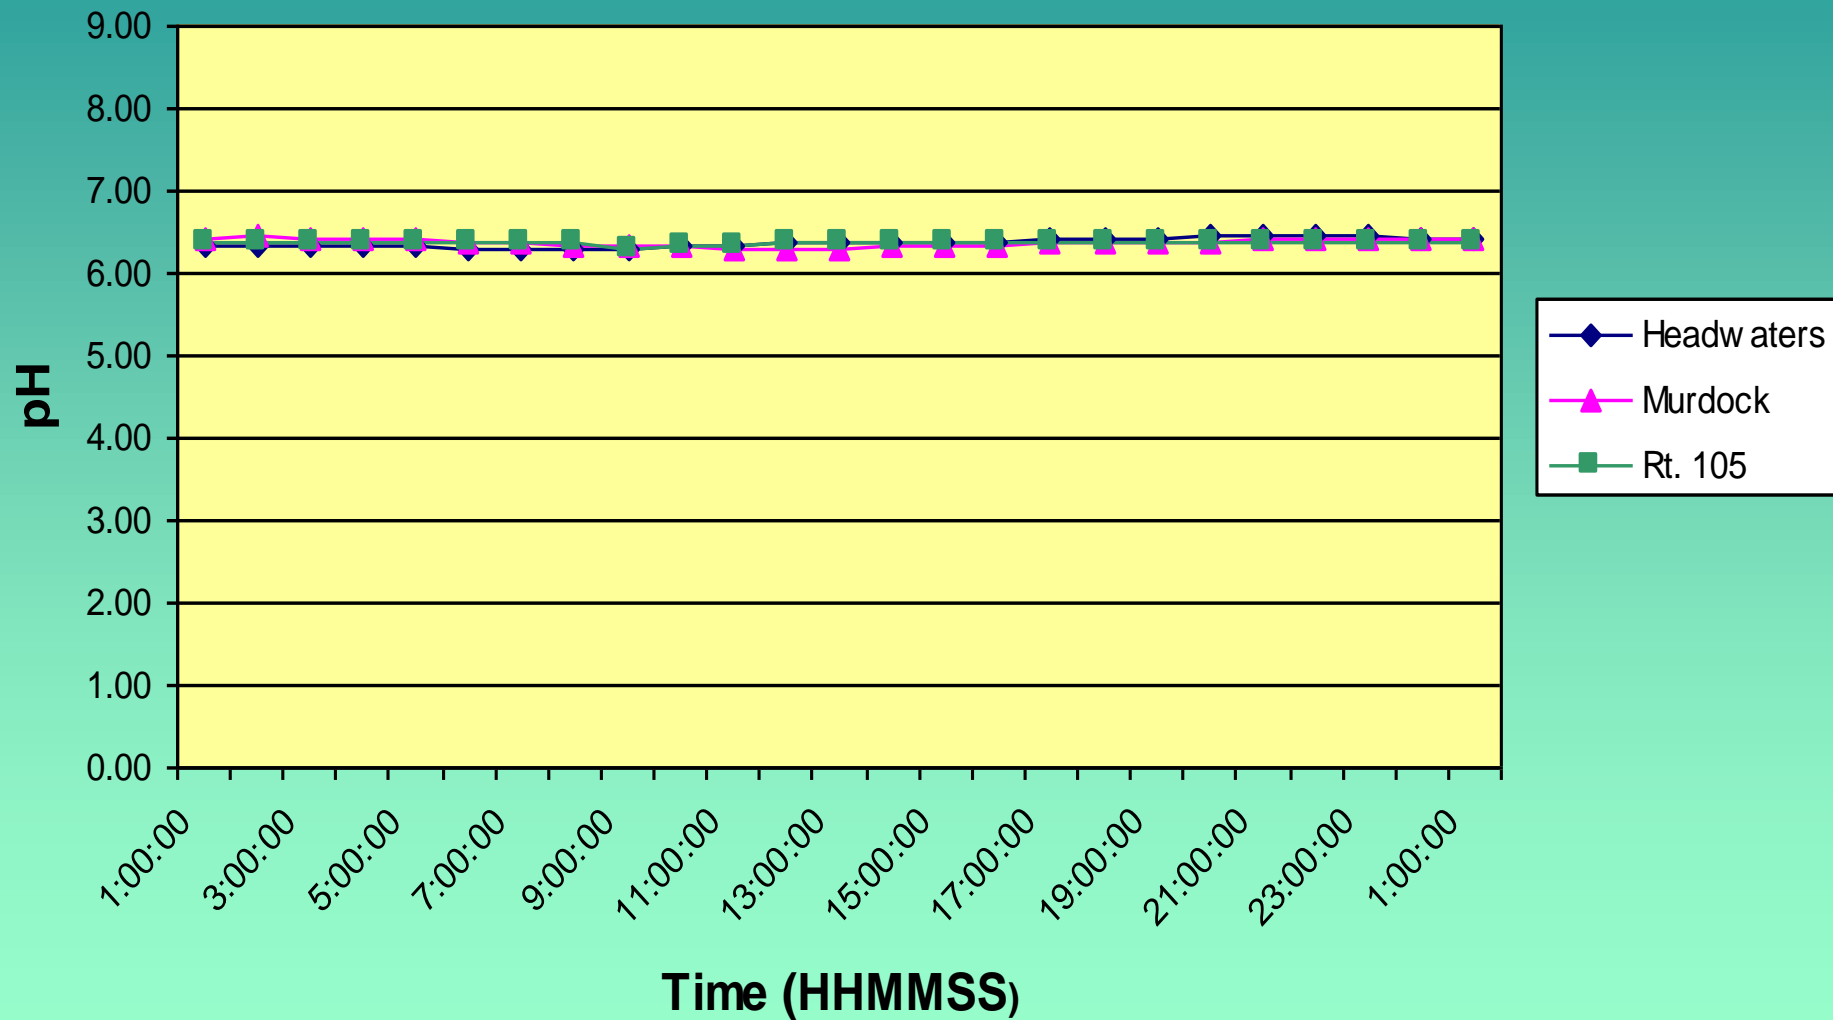
# ph vs. time, Nemasket River, 11/3-11/4/2006

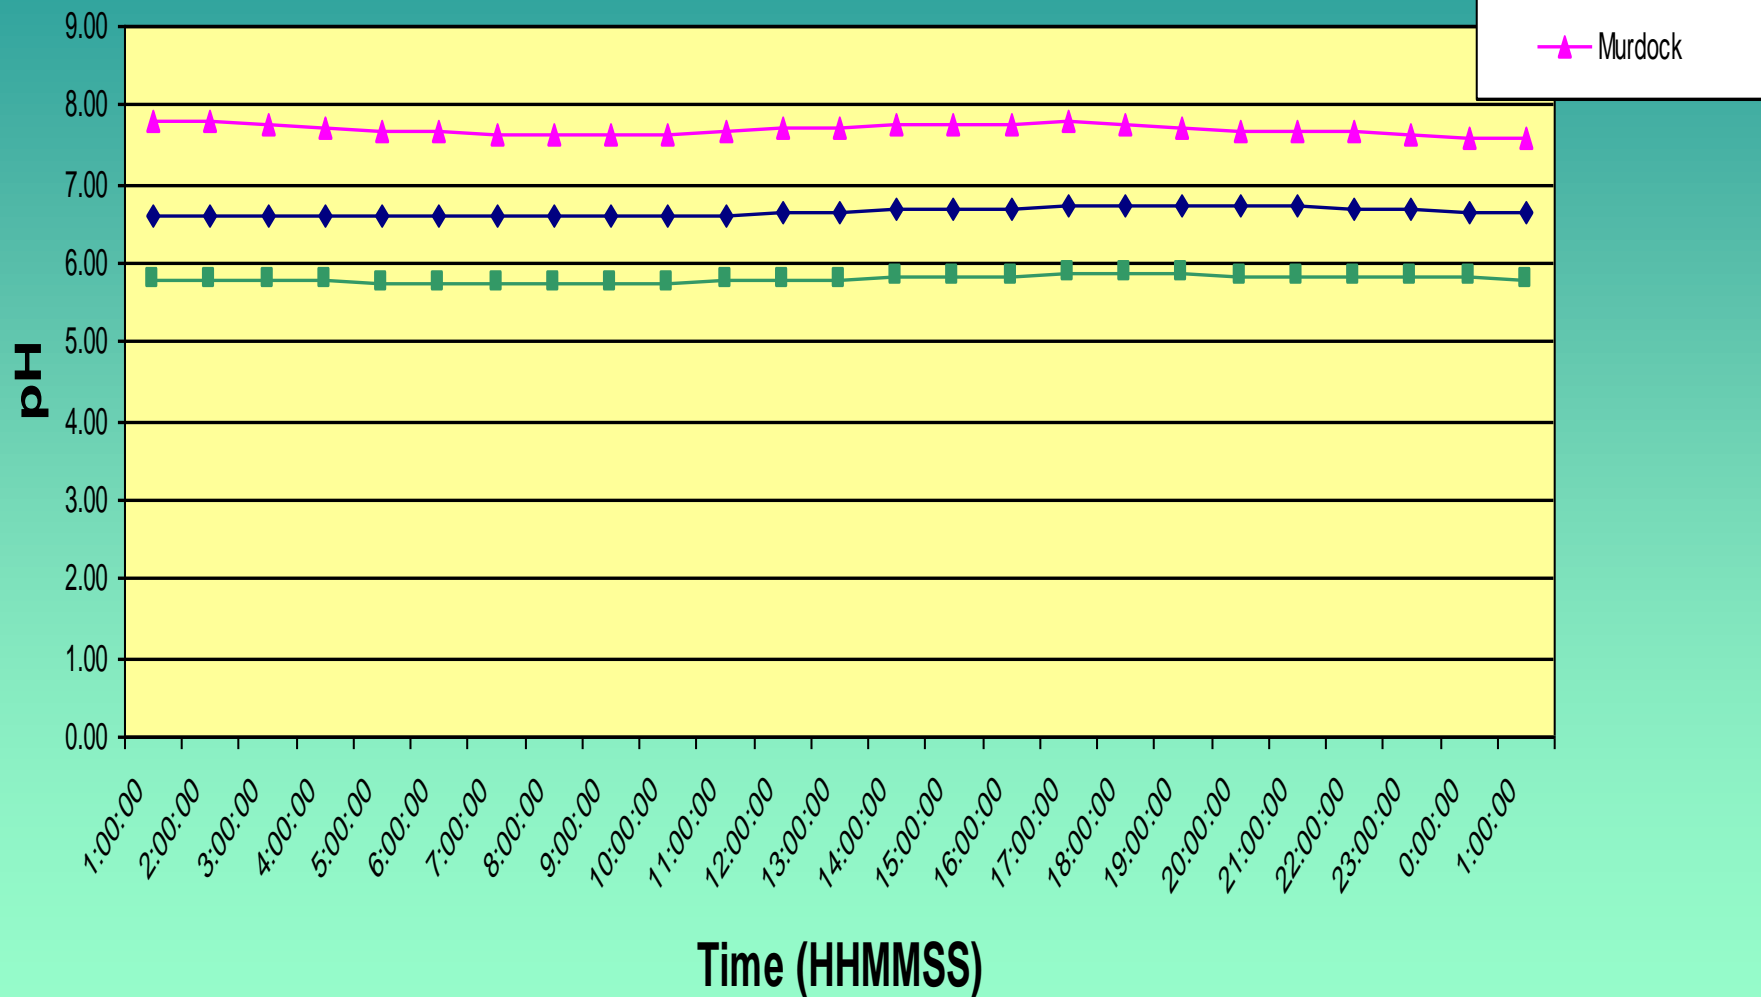
# pH vs. Time, Nemasket River, 04/03/07-04/04/07

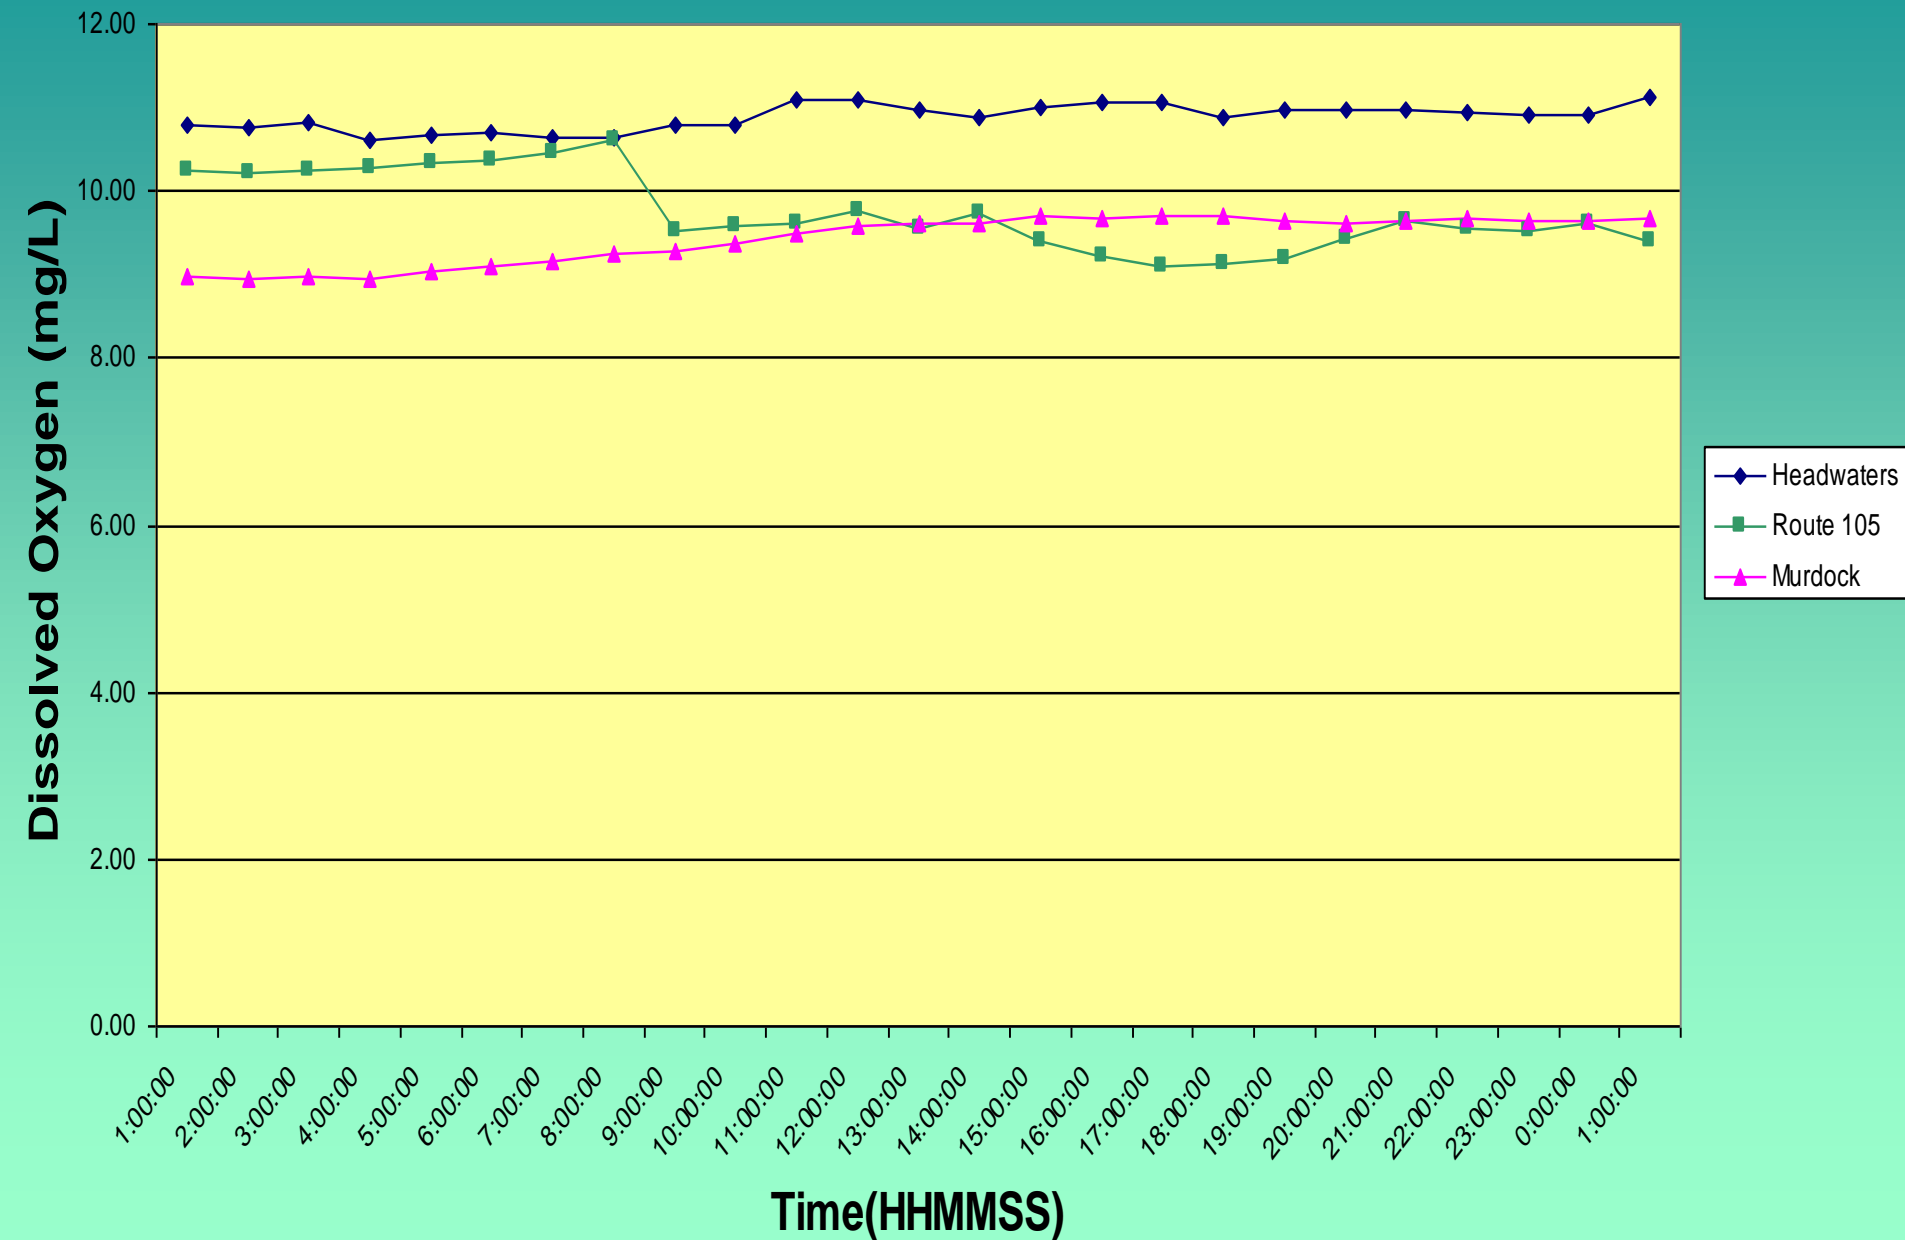
# Dissolved Oxygen vs. Time, Nemasket River, Nov. 3-4, 2006

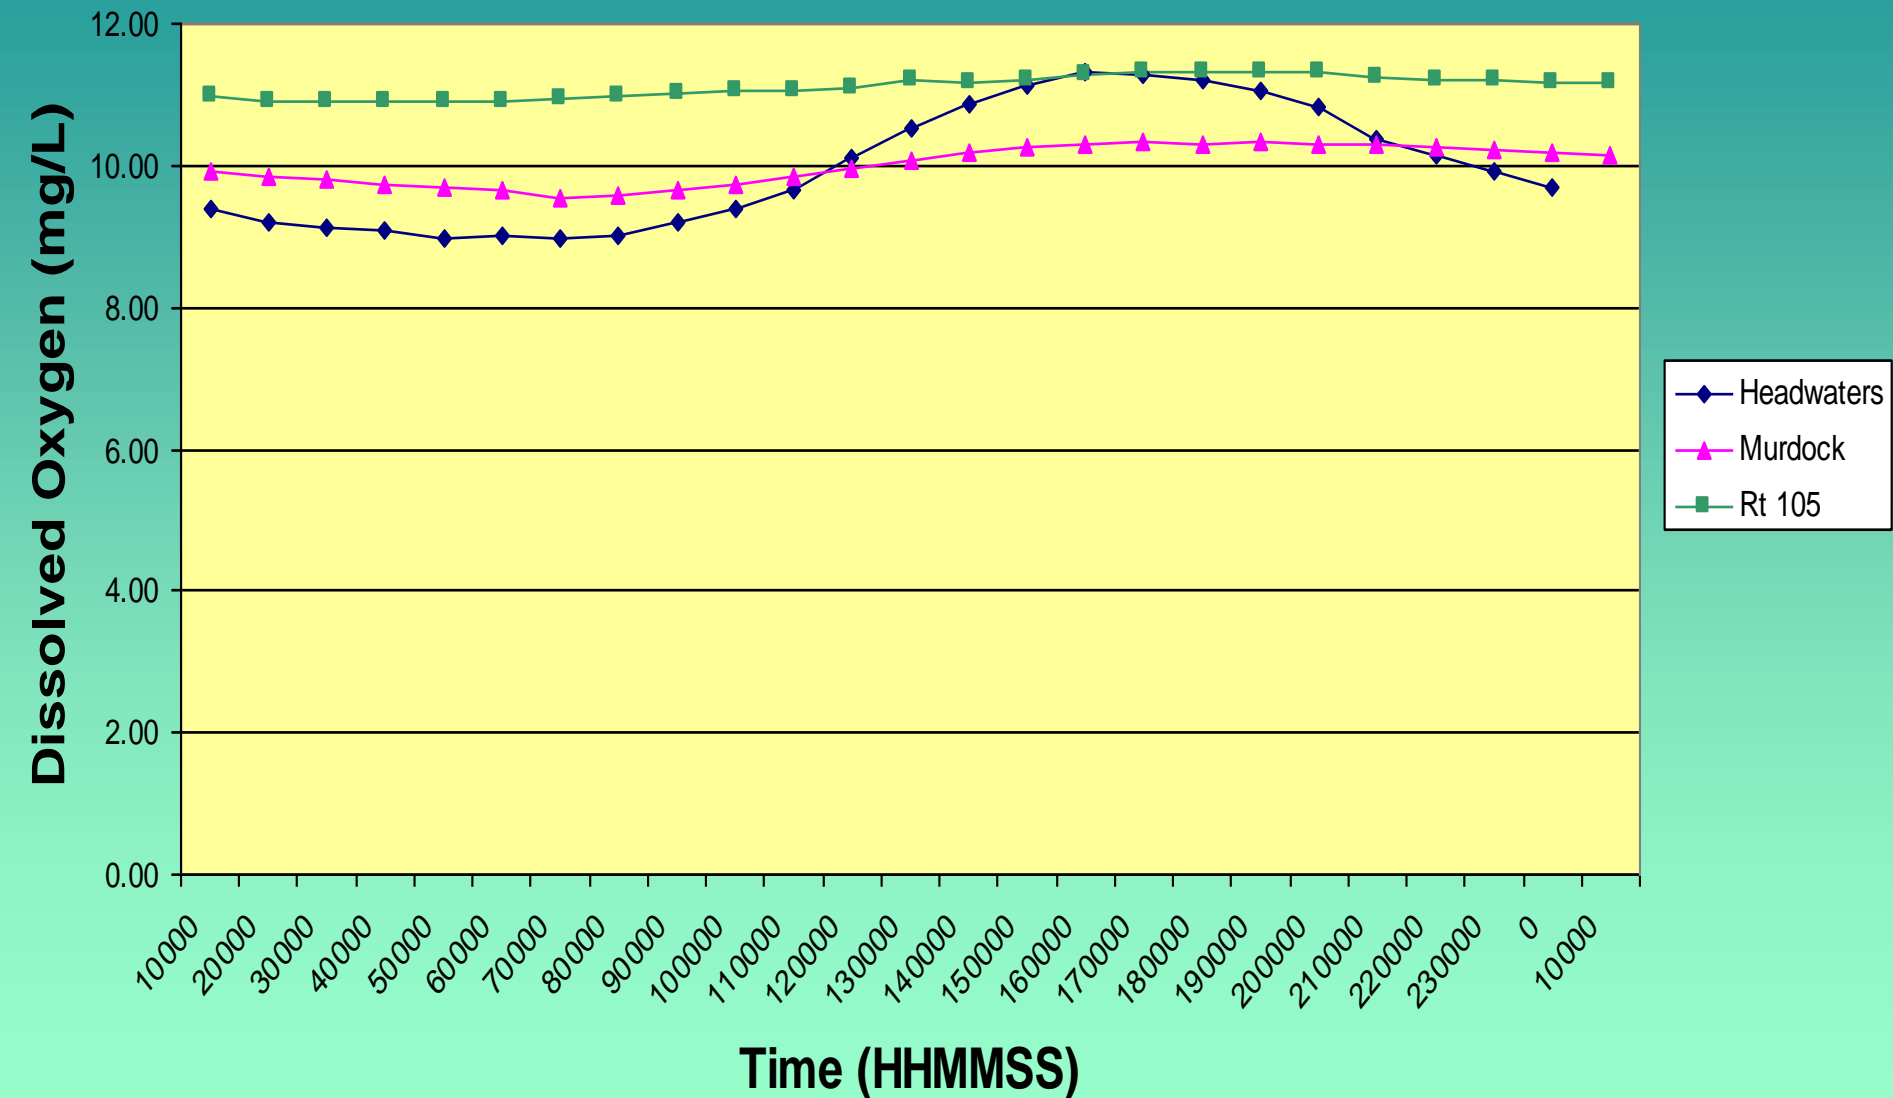
# Dissolved Oxygen vs. Time, Nemasket River, April 3-4, 2007

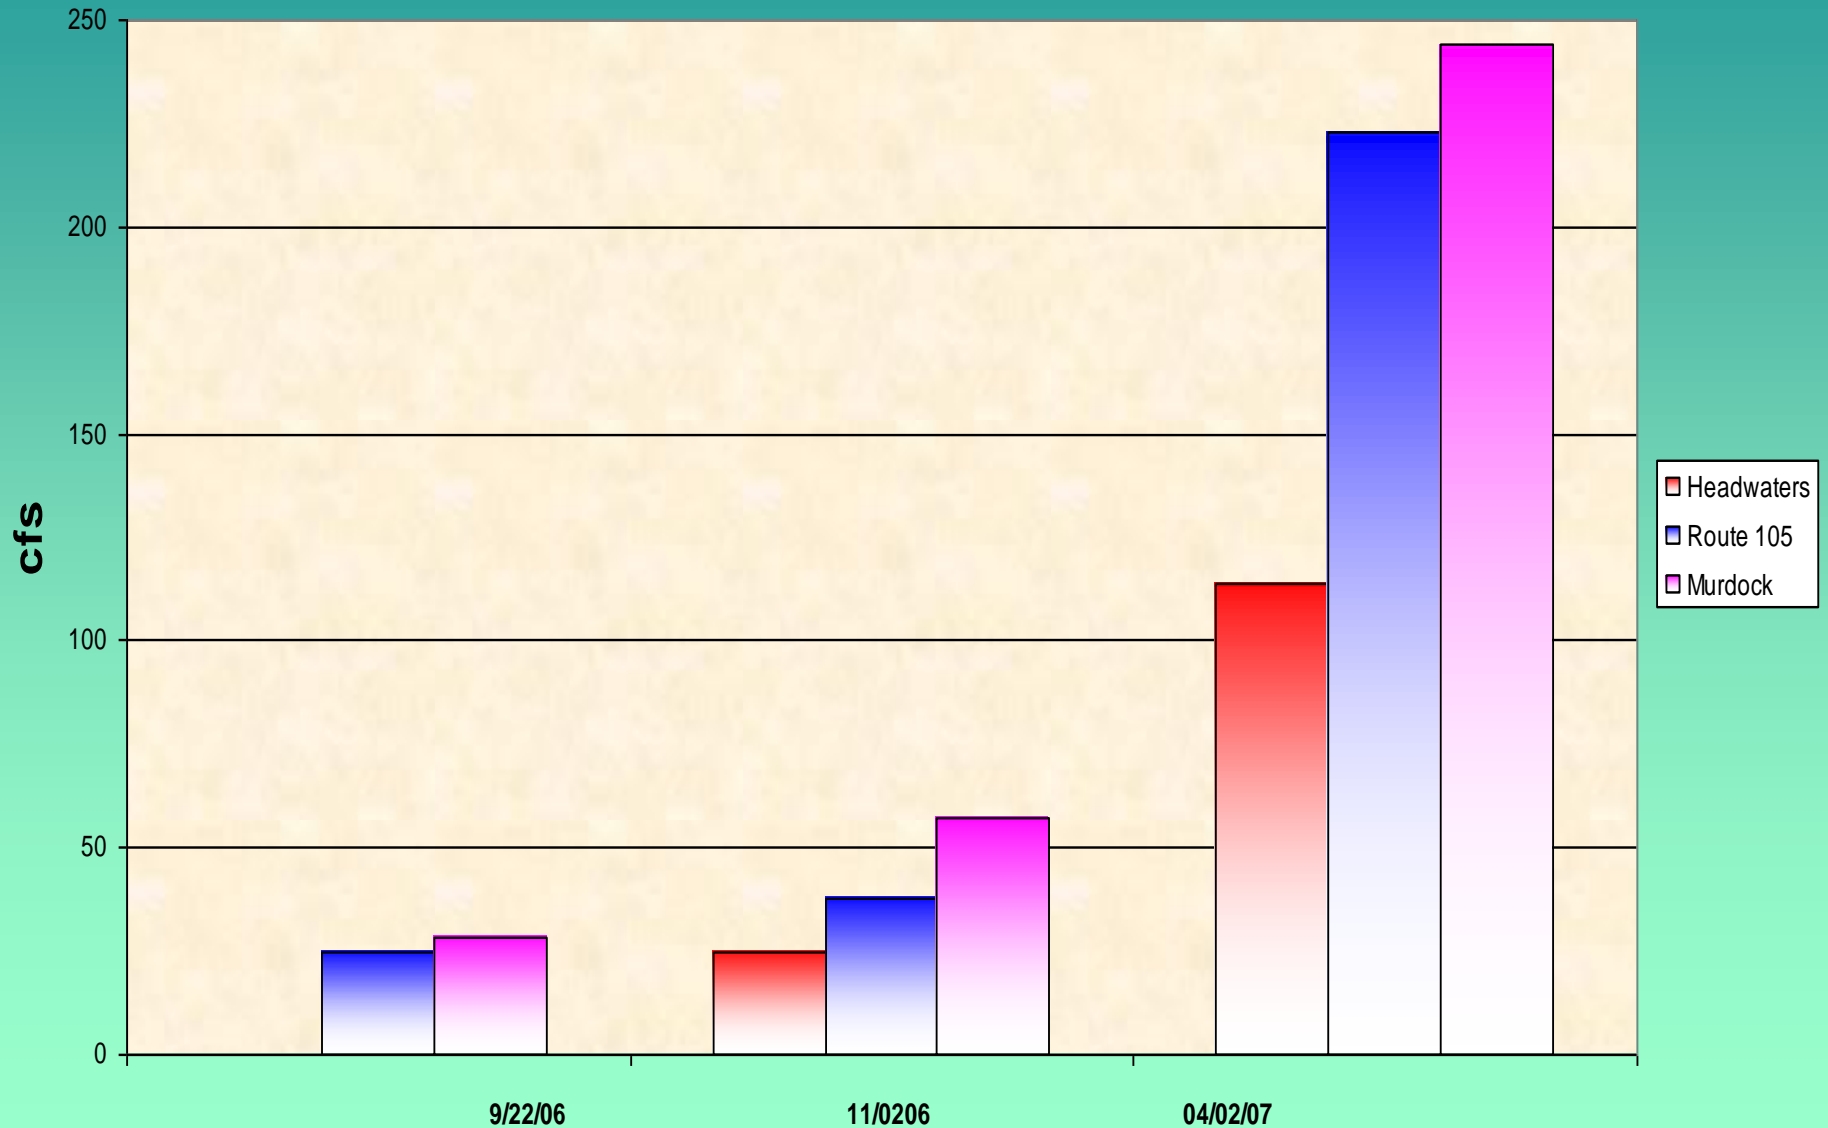
# Discharge, Nemasket River, 2006-2007

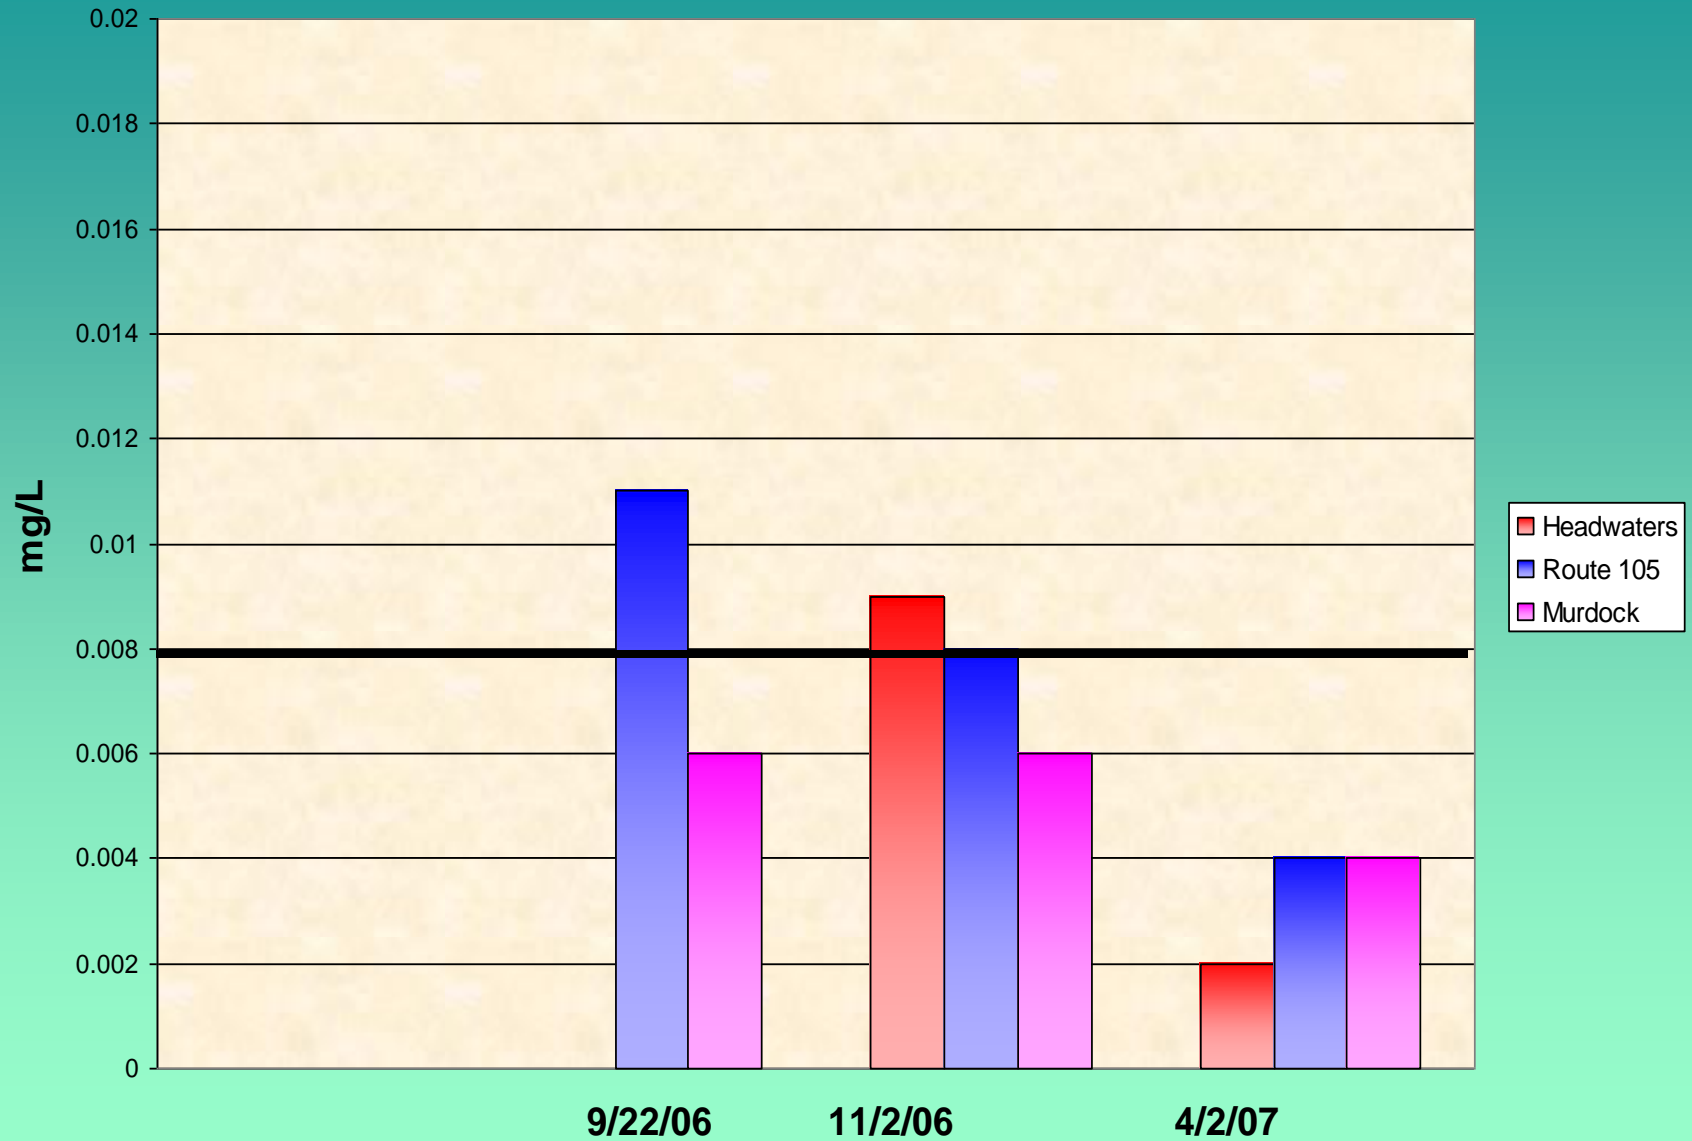
## Reactive Phosphorus Concentrations, Nemasket River, 2006-2007

- Our hypothesis has been proven correct.
- Nutrient Loads are higher at Murdock Street than the other two sites.
- Our conclusion is that the Middleboro Wastewater Treatment Plant causes stress to the Nemasket River.
- The water quality of Route 105 is excellent, and the water quality of Murdock is fair based on the Family Biotic Index.

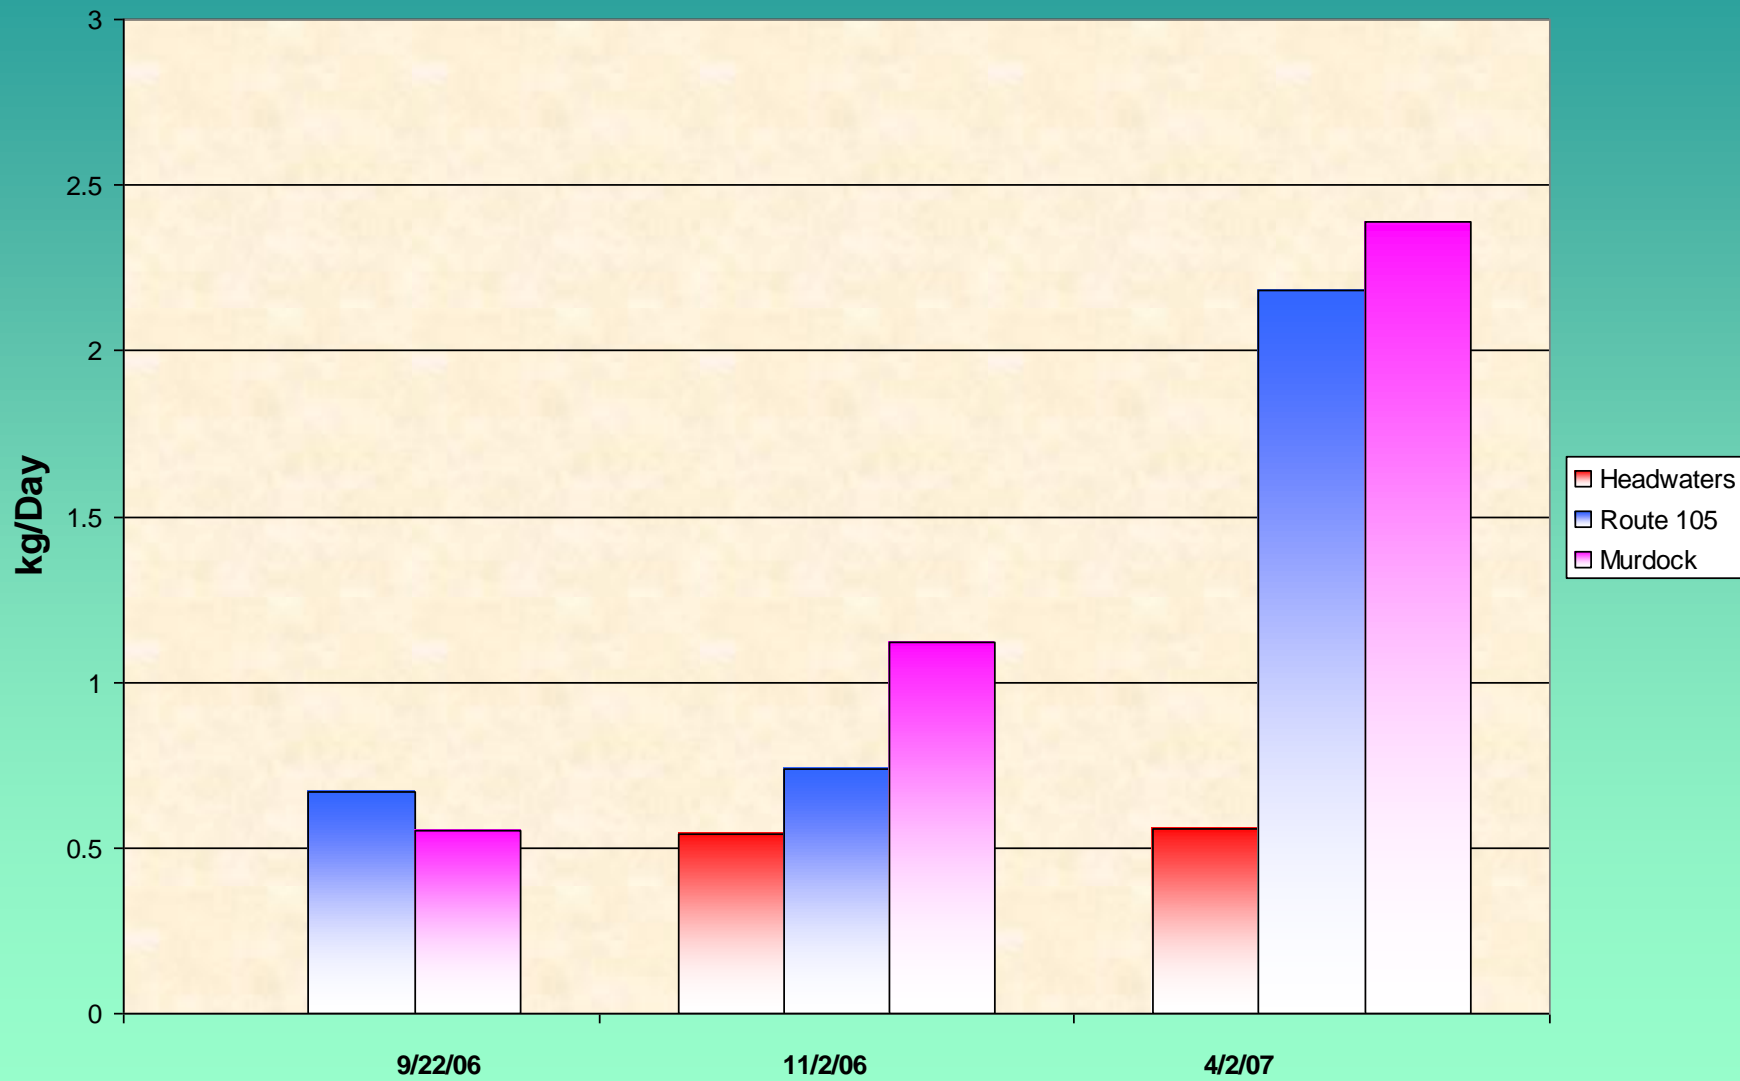
## Load for Reactive Phosphorus, Nemasket River, 2006-2007
